## PACS Newsletter

Nr. 19, 12 March 2008

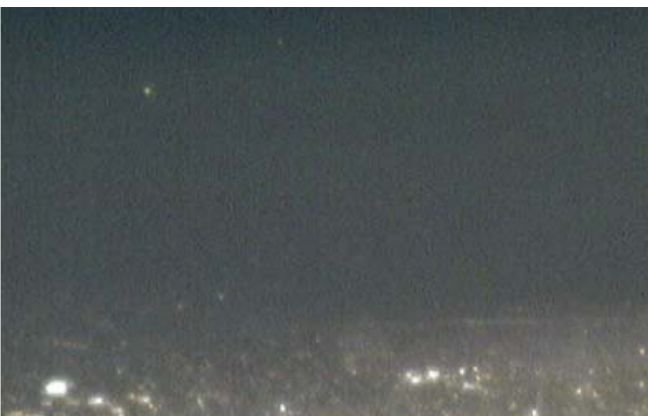
**Fig. 5: Left:** Contamination of Trog 1 and 2 mirrors, other mirrors not affected. Above: Trog 1 mirror after cleaning, some old scratches remain.

After Astrium (Friedrichshafen) had mounted the shields over the Herschel optical bench, they did a last check, shining down a flashlight through the hole/baffle in the shields, when they noticed serious contamination, in the form of whitish spots, on the first mirror of our entrance optics. Similar contamination was also observed on an external, auxiliary alignment mirror on top of the PACS structure. A visual inspection confirmed that this was definitely different from the state the mirror was left in before ILT-3. Since the cause of this contamination was unknown, the fear grew that it could be something (condensation / corrosion) that may have affected more/all mirrors in PACS.

It was then jointly decided between Project and PACS to remove the shields for further investigation. Application of a camera with special optics allowed focusing through the PACS entrance optics all the way down to the Lyot stop and to take pictures of individual mirror surfaces. The key initial findings are shown in figure 5 ("Trog1-before" and "Trog2-before"), which showed spots all over the place on the first mirror, but also a strip of contamination on the adjacent, second mirror. The relatively sharp border of the contamination on this second mirror strongly suggested that the contamination must have come from the outside, through our rectangular entrance aperture, and in a rather directional way. This hypothesis was further supported by the images of the mirrors further downstream, which - apart from a few scratches - didn't show any contamination or other degradation of their optical surfaces.

It was then agreed by all involved parties that under these circumstances an in-situ cleaning attempt should be made, to avoid the otherwise unavoidable de-integration of the FPU with all associated risks, like ESD damage of the CREs and other, smaller issues. Indeed, it was possible to perform a wet cleaning process (with de-ionised water and various forms of alcohol) on the affected mirrors with good results - see figure 5 ("Trog1-after"), which even in strong light shows hardly any contamination anymore. What comes out more prominently on the clean surface, however, are lots of fine scratches, which have been introduced by an earlier attempt to wipe off some dust before the ILT. (Note in passing: whatever we have measured in the lab was done with these scratches, already).
