PACS Newsletter

Nr. 14, 22 December 2006

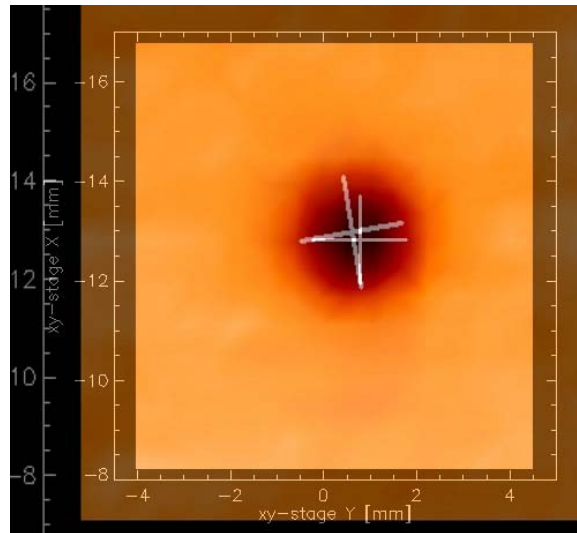
Fig.3: Overlay of the PSFs measured for the central module in the red and blue array. Both arrays are registered within $<1/5$ of a pixel – this means the alignment of the dichroic is ok; the misalignment must occur entirely in the slicer / rest of the spectrometer.

slice. The red spectrometer shows exactly the same anomaly as the blue one. The good news is that through an analysis of these data (in particular comparing blue and red data) we believe we understand the cause for the problem: it is not the dichroic, which seems to be in perfect condition (see Figure 3). The misalignment must occur in the slicer optics (the slicer itself and the capture and slit mirrors), because the problem occurs in both the blue and the red spectrometer. Probably these mirrors have moved during cryo-vibration. We will warm up and open PACS over Christmas to investigate this problem in more detail (and hopefully fix it). During this time we also hope to fix the chopper problem by replacing the chopper (which is actually the FS module) with another module (the original FM module). An NRB about the chopper was held this week. The slicer misalignment NRB will be held on January 4 at MPE.
